RELIABILITY INVESTIGATION OF LOW NOISE GAAS FETS.(U)

K
RADC-TR-61-161
Final Technical Report
July 1961

RELIABILITY INVESTIGATION OF LOW NOISE GaAs FETs

Hughes Aircraft Company

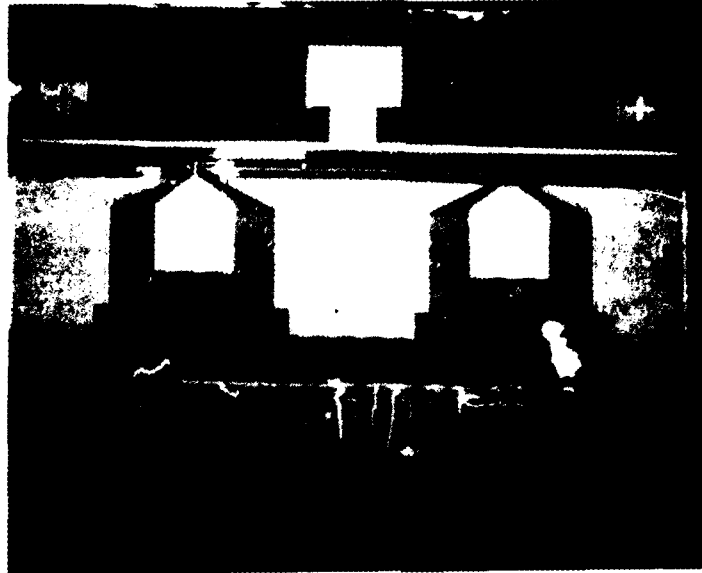
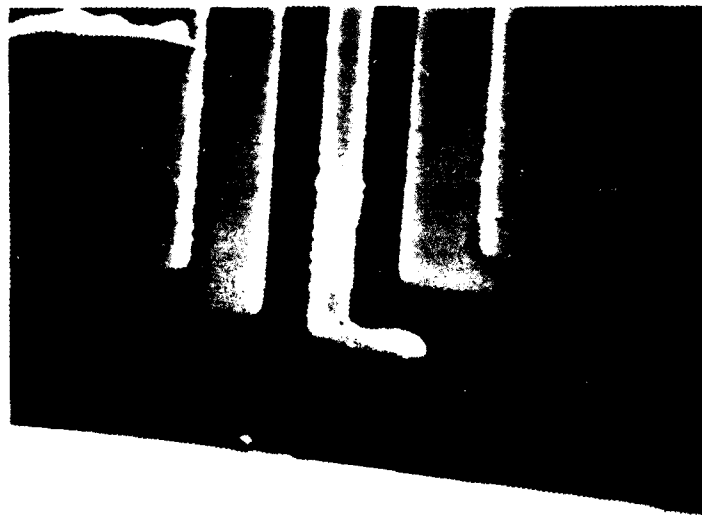
Figure 2-5 FET D-1. (a) Overall view, 196X.
(b) Gate finger end, glass not etched, 4200X. Note interesting mesa step offset. Gate end crosses some shallow step as at pad connector.

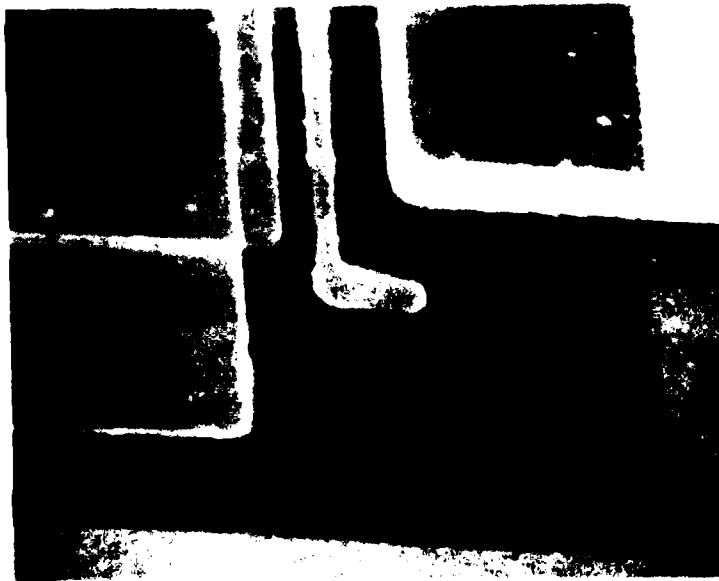
Figure 2-8 FET D-2. (a) 4400X view of gate metal after attempted removal of glass with buffered HF. Two layers are glass and gate metal. (b) Gate finger end, 4100X. Gate length, 0.8 μm ; S-D spacing, 4.0 μm . Glass removed from ohmic contact.

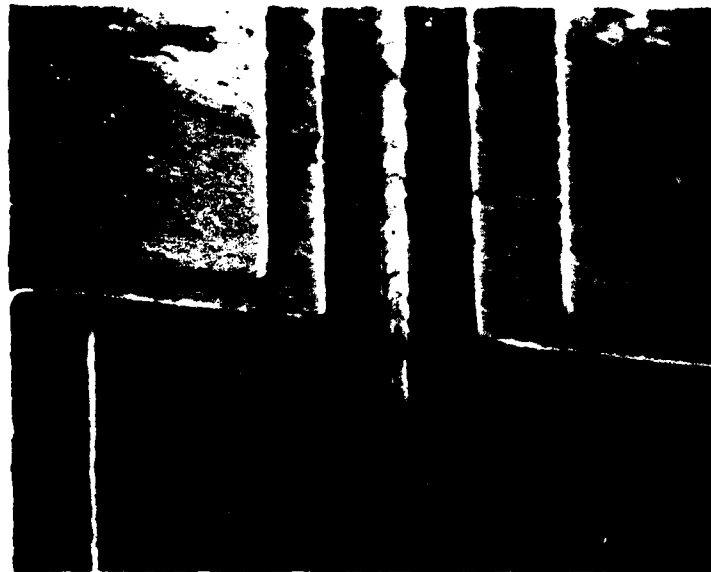
Figure 2-11 FET H-1. (a) Gate finger, 9000X, with glass. (b) Gate finger after buffered HF etch to remove glass, 4500X. Note etched channel under gate.

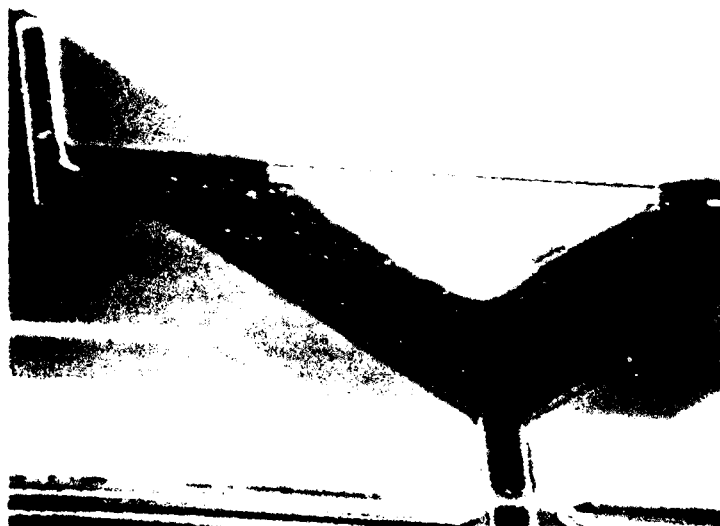
Figure 2-22 Type R-2 FET. (a) Overall view, 88X, glass intact. Arrow shows view of Figure 2-23(b). (b) Gate pad area. Light area at top is gate pad opening in the glass. 860X, glass intact. Note gray refractory metal band just below gold gate pad.

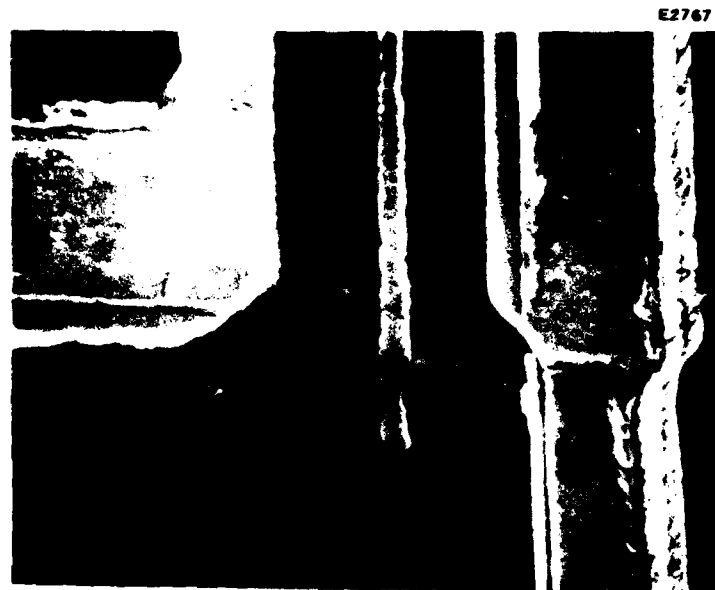
Figure 2-23 Type R-2 FET. (a) Glass removed, 4200X. Gate length, 1.4 μm ; S-D separation, 7.3 μm . Note channel etch around gate and GaAs etching at S-D edges. (b) Glass etched off, 4400X. Detail of gate pad connector. Gate to left. Note separated pad over step. Refractory metal band is visible, lower left.
